Intermediate Temperature Stress Rupture of Woven SiC Fiber, BN Interphase, SiC Matrix Composites in Air

Gregory N. Morscher
Case Western Reserve University, Cleveland, Ohio

Prepared under Contract NCC3-404

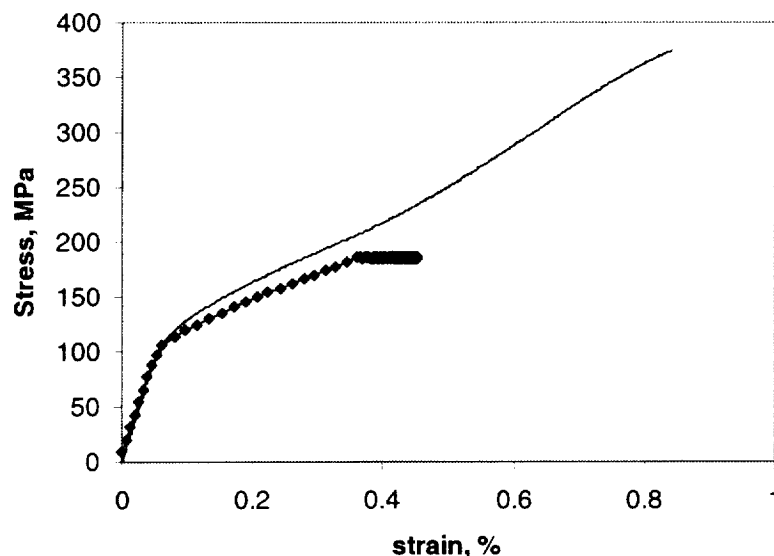
Figure 3.19: Stress-strain behavior of material tested at room temperature fast fracture and the rupture test.

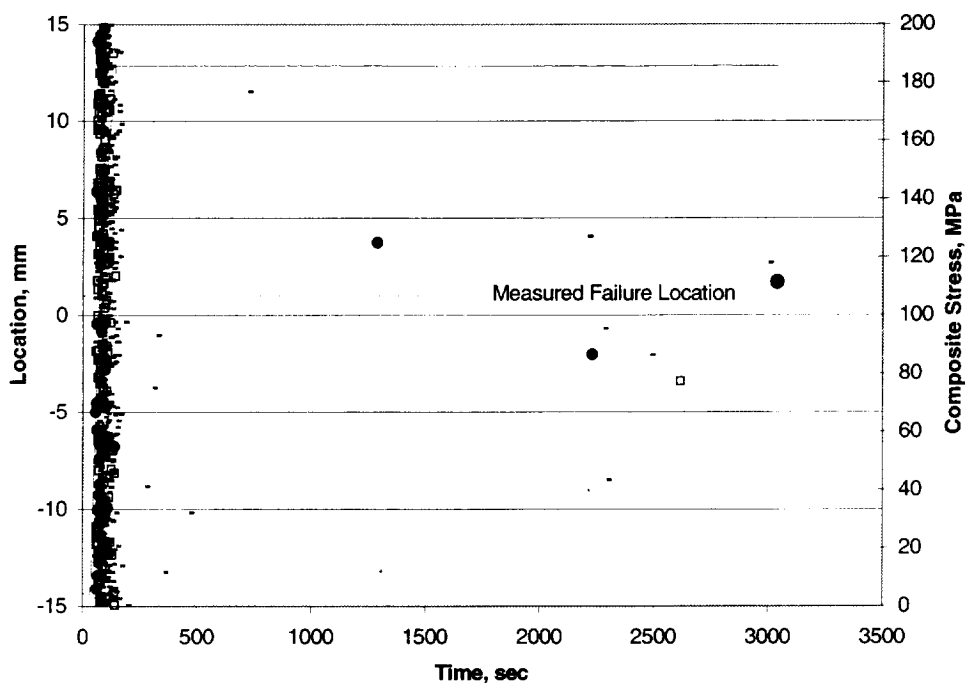
Figure 3.20: Stress and AE event location versus time for 186 MPa, 815°C stress-rupture test.

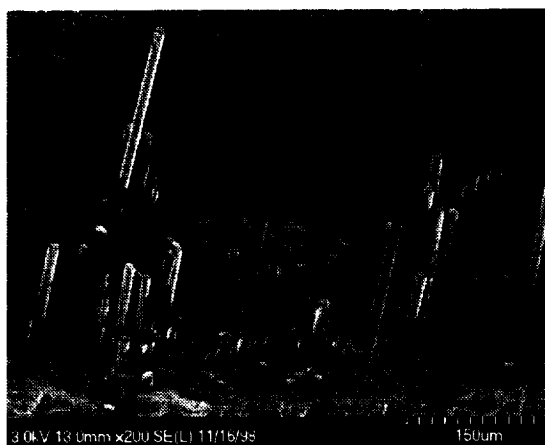
(c)

The fracture surface of the highest stress, shortest time rupture specimen is shown in Figure 3.21. Most of the fracture surface was characterized with fiber pullout. There were a few tows that were embrittled (Figure 3.21b). However, most of the tows were characterized with embrittlement of some of the outer fibers (no pullout) in a tow and significant pullout for most or some of the inner fibers in a tow (Figure 3.21 c and d).

Figure 3.21: FESEM micrographs from CVI-matrix rupture (186 MPa; 0.8 hr; 815°C).

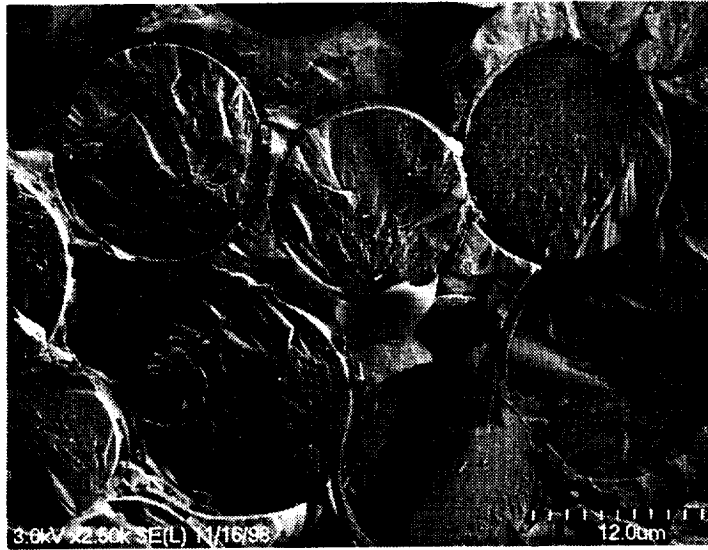
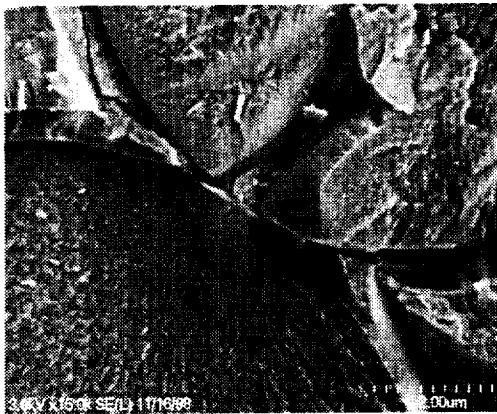
Figure 3.21: Continued.

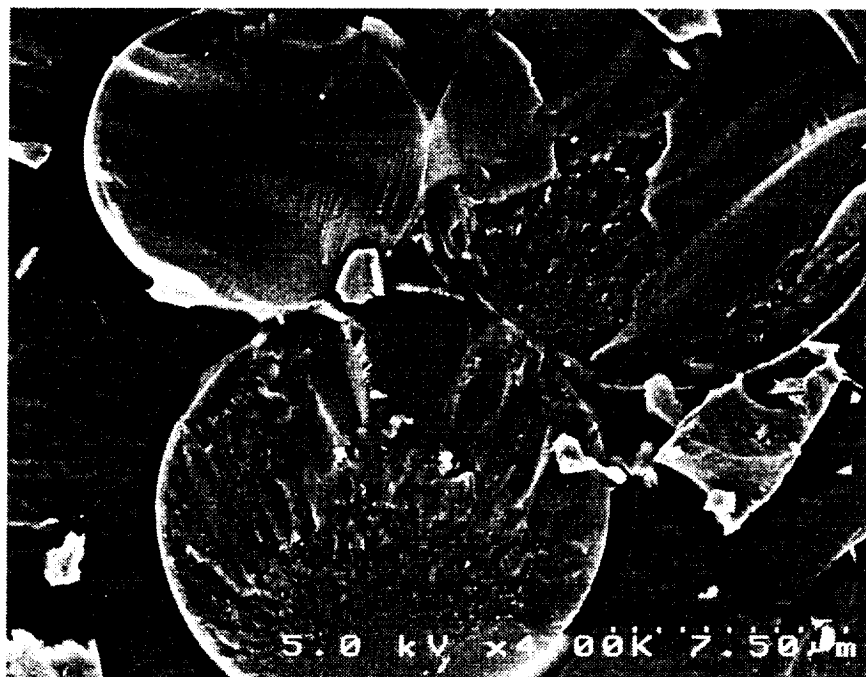
(b)

Figure 3.22: FESEM micrographs from CVI-matrix rupture (139 MPa; 2 hr; 815°C).

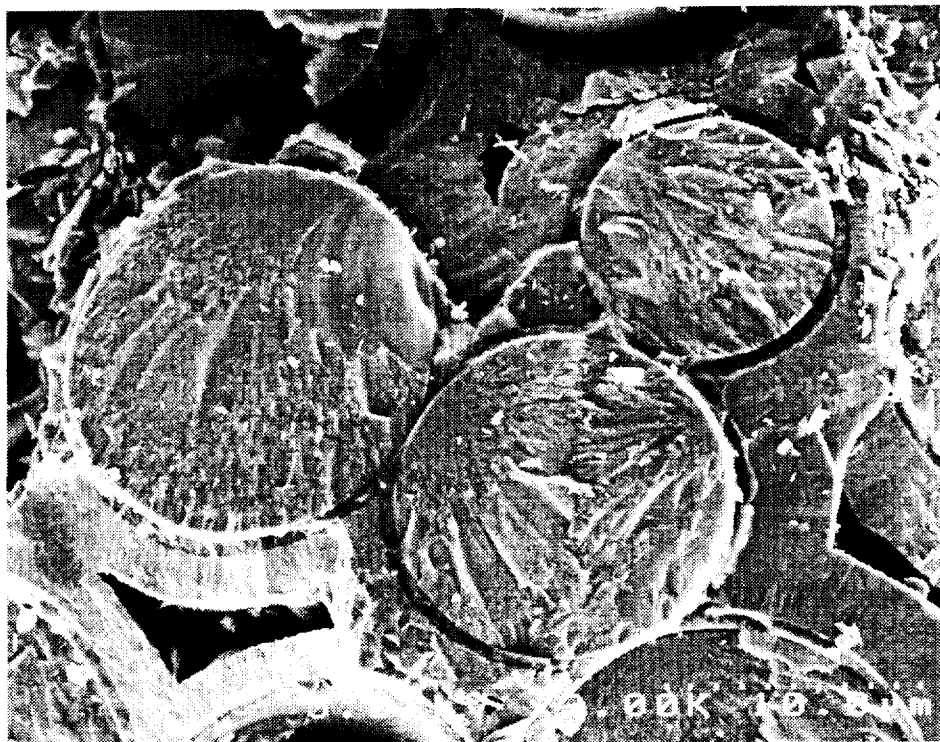
(c)

Figure 3.22: Continued.

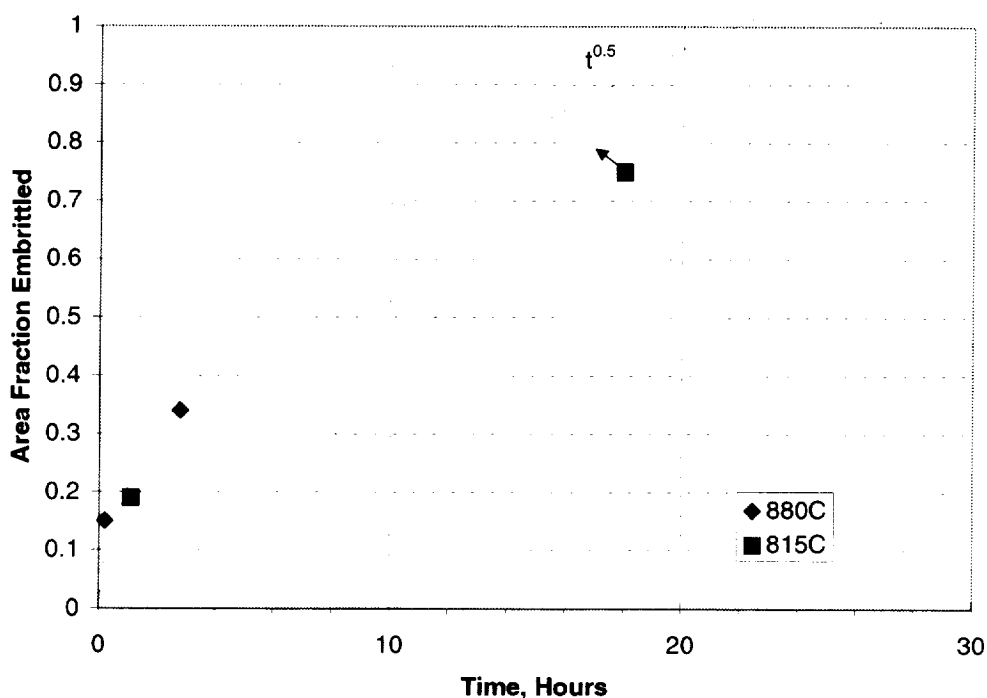
Figure 4.1: Area fraction of embrittled load-bearing tows versus time determined from the fracture surfaces of rupture specimens. The shortest time data points correspond to Regime I rupture and the longer time (with arrow) data point corresponds to a Regime II rupture condition where a condensed phase oxidation reaction product was apparent three plies from the surface of the composite cross-section.

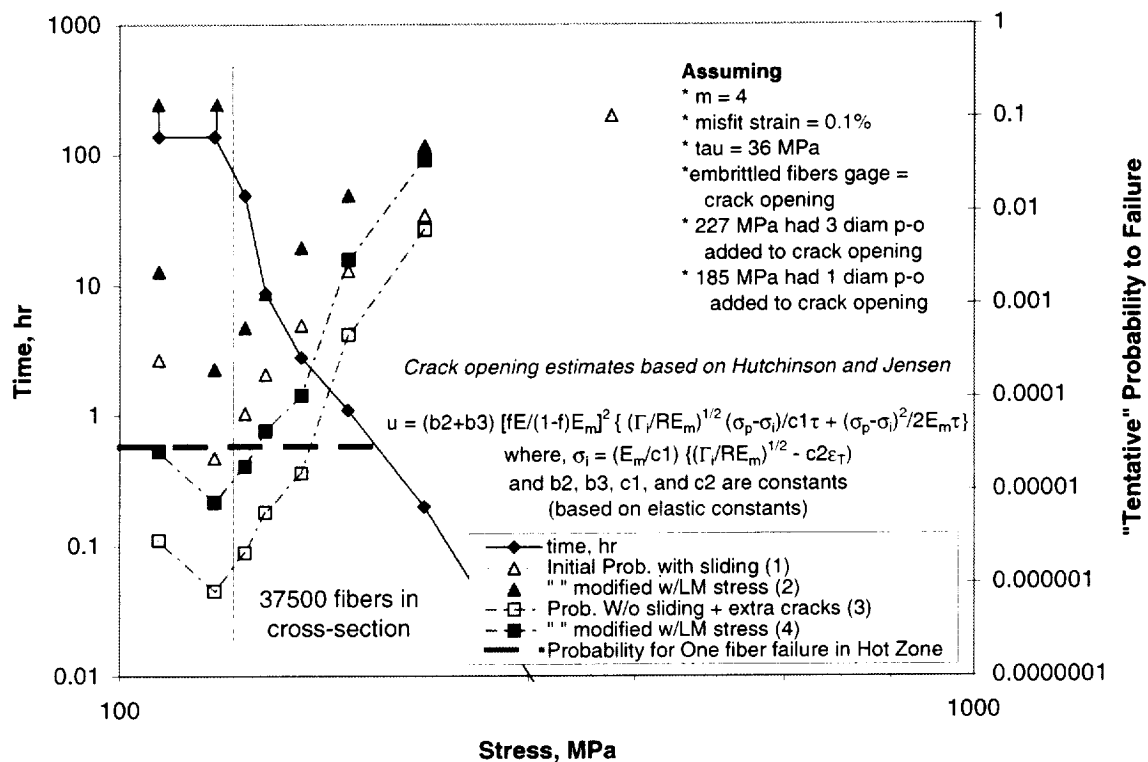
Figure 4.2: Probability to failure for as-produced and rupture conditions. The horizontal dashed line indicates the probability for one fiber to break in the hot zone section of the specimen. The vertical line indicates the demarcation above which rupture specimens failed during the test.

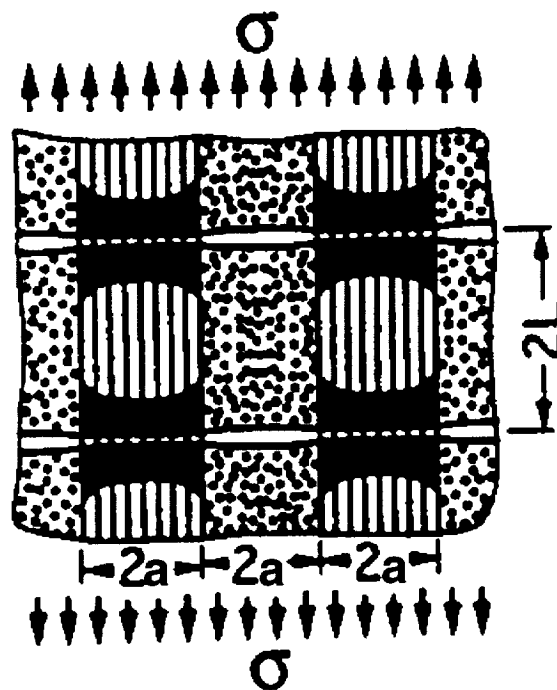
Figure 4.3: Schematic representation of stress-concentration at load-bearing fibers in a 2-ply composite (from Xia et al. [18]).

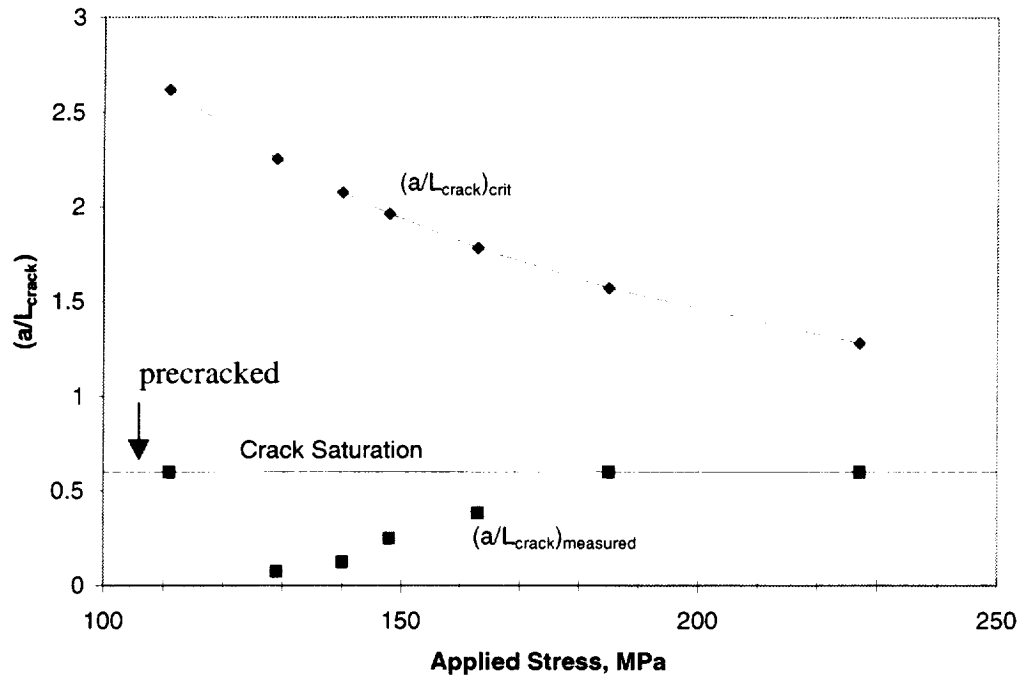
Figure 4.4: Critical crack density for elimination of stress-concentration for MI matrix composite rupture based on Xia et al. [18].

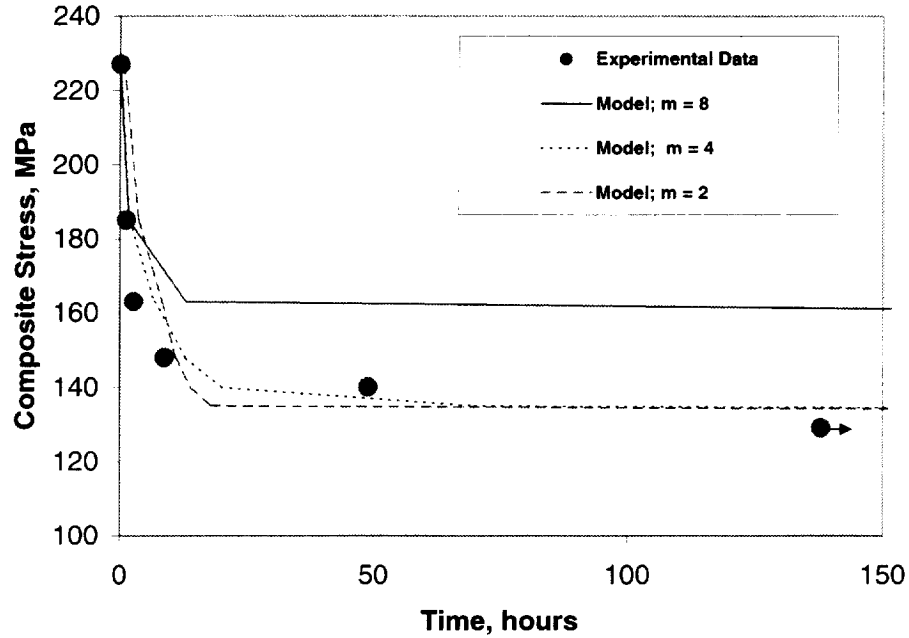
Figure 4.5: MI composite rupture modeled for through-thickness matrix cracking.

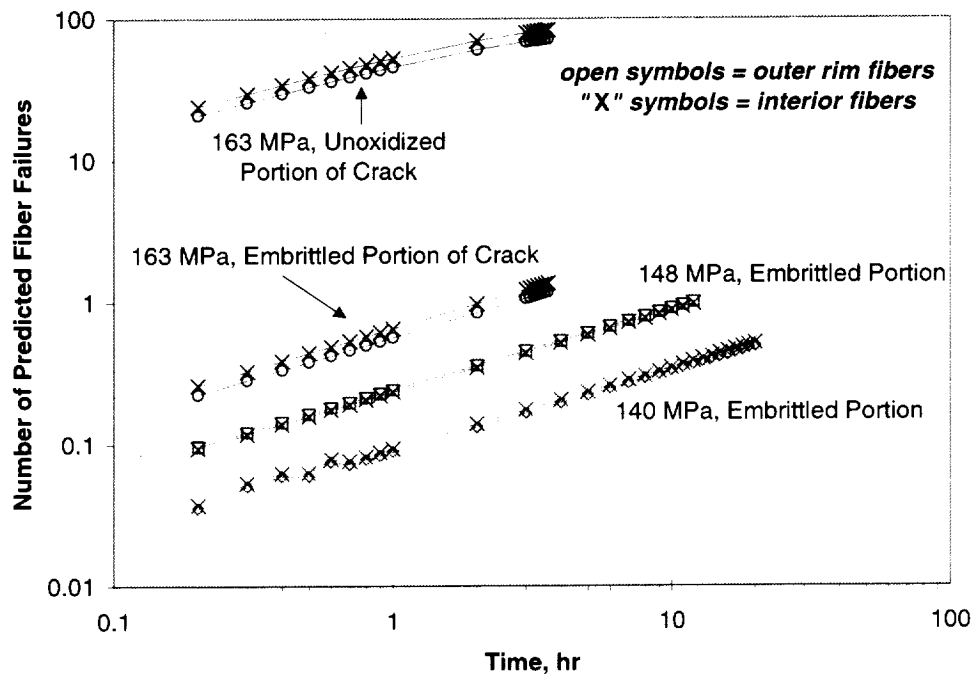
Figure 4.6: Predicted number of fiber failures at the outer-rim of the embrittled fiber-bundles and in the interior of the embrittled fiber-bundles throughout the gage section of the composite for $m = 4$.

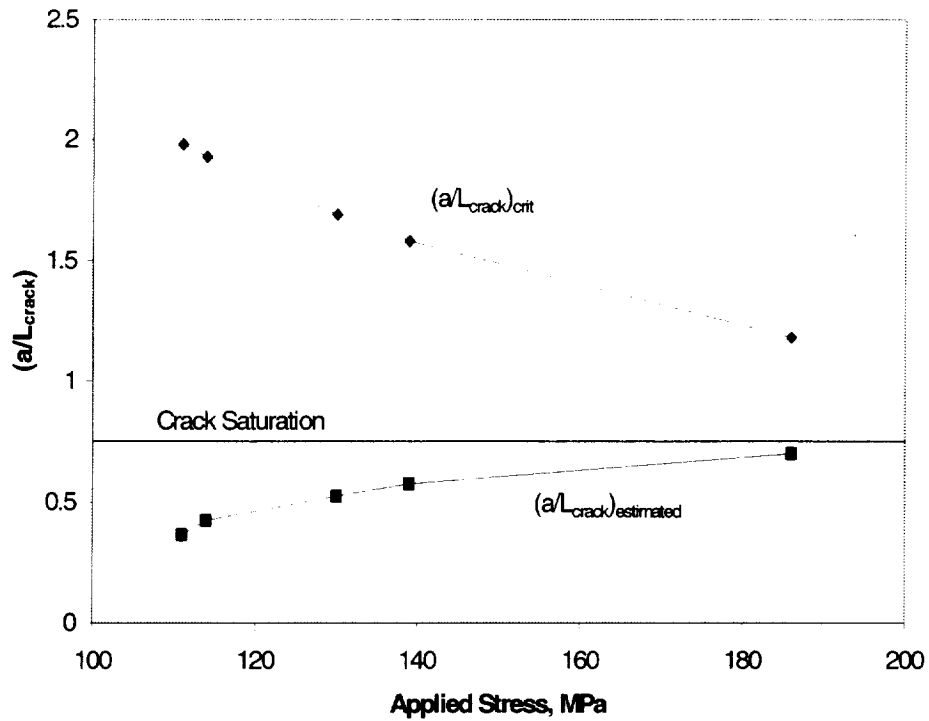
Figure 4.7: Critical crack density for elimination of stress-concentration for MI matrix composite rupture based on Xia et al. [18].

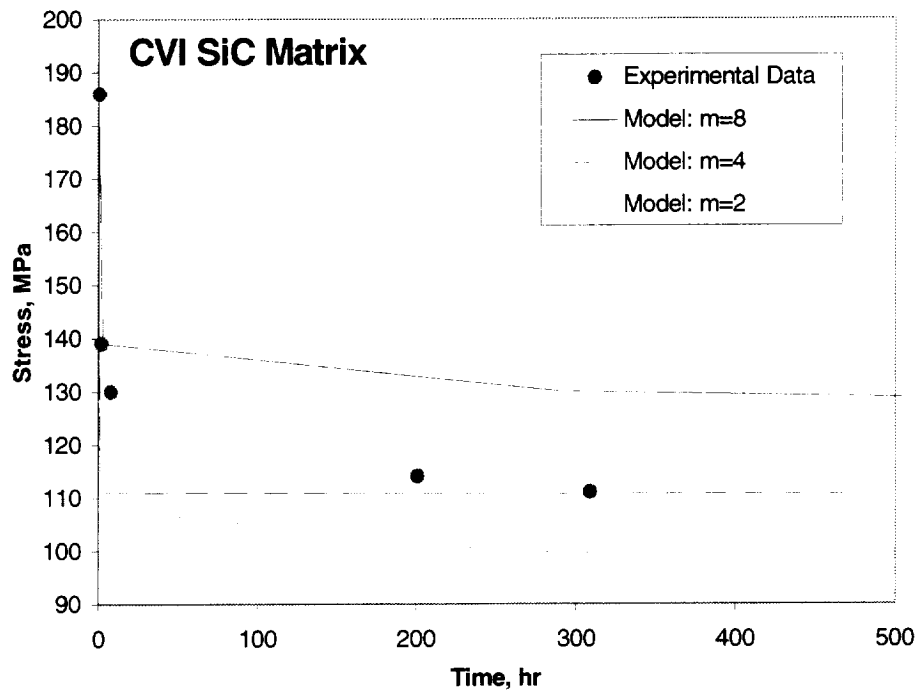
Figure 4.8: CVI composite rupture modeled for through-thickness matrix cracking with various values for m .

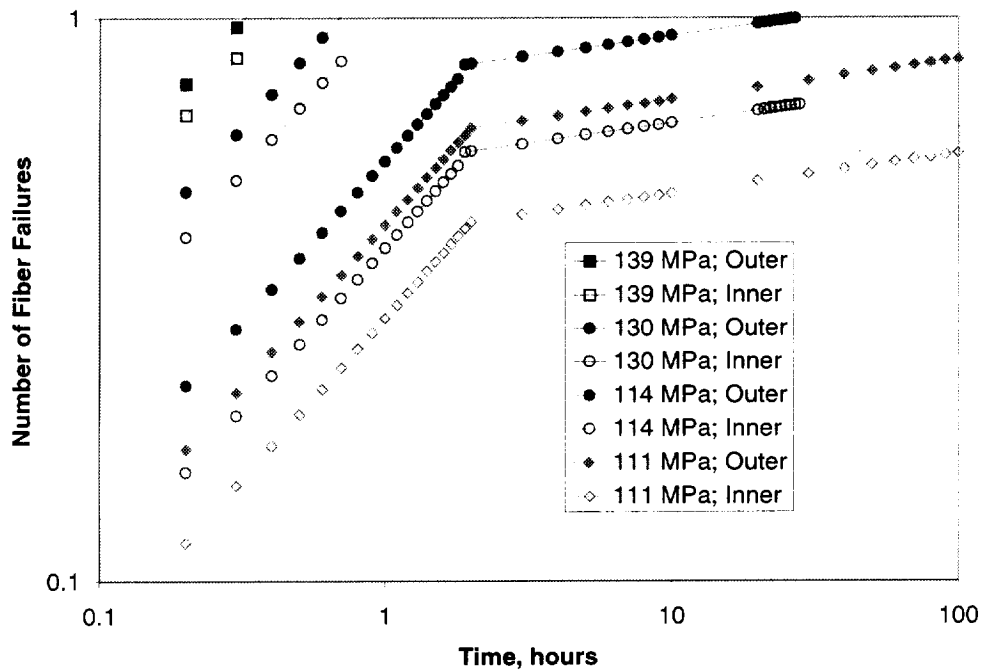
Figure 4.9: Predicted number of fiber failures at the outer-rim of the embrittled fiber-bundles and in the interior of the embrittled fiber-bundles throughout the gage section of the CVI composite for $m = 4$.

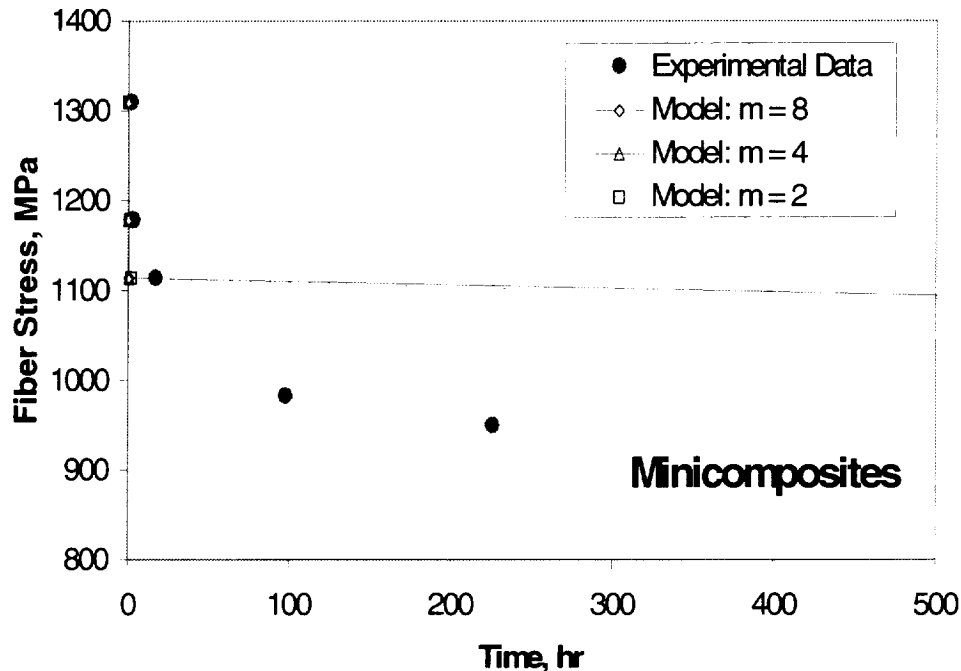
Figure 4.10: CVI SiC minicomposite rupture (950°C) modeled for through-thickness matrix cracking with various values for m .

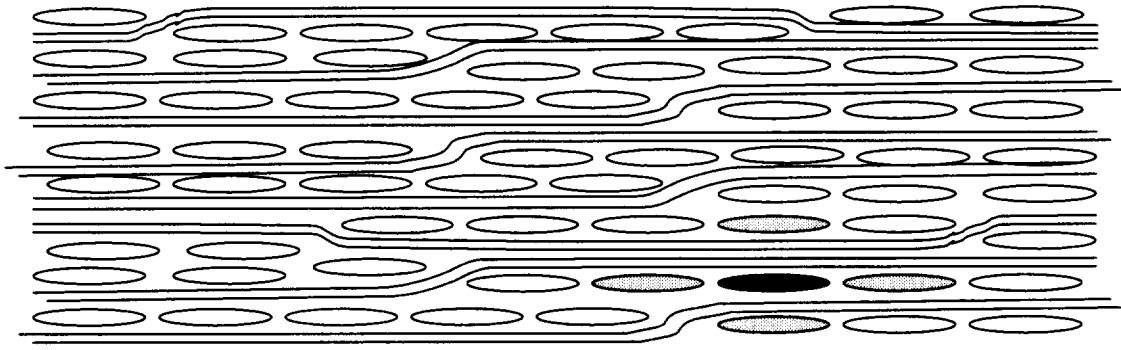
Figure 4.11: Schematic representation of five harness satin composite cross-section. Black bundle represents a failed bundle and grey bundles represent the nearest-neighbor bundles which share the load of the failed bundle.

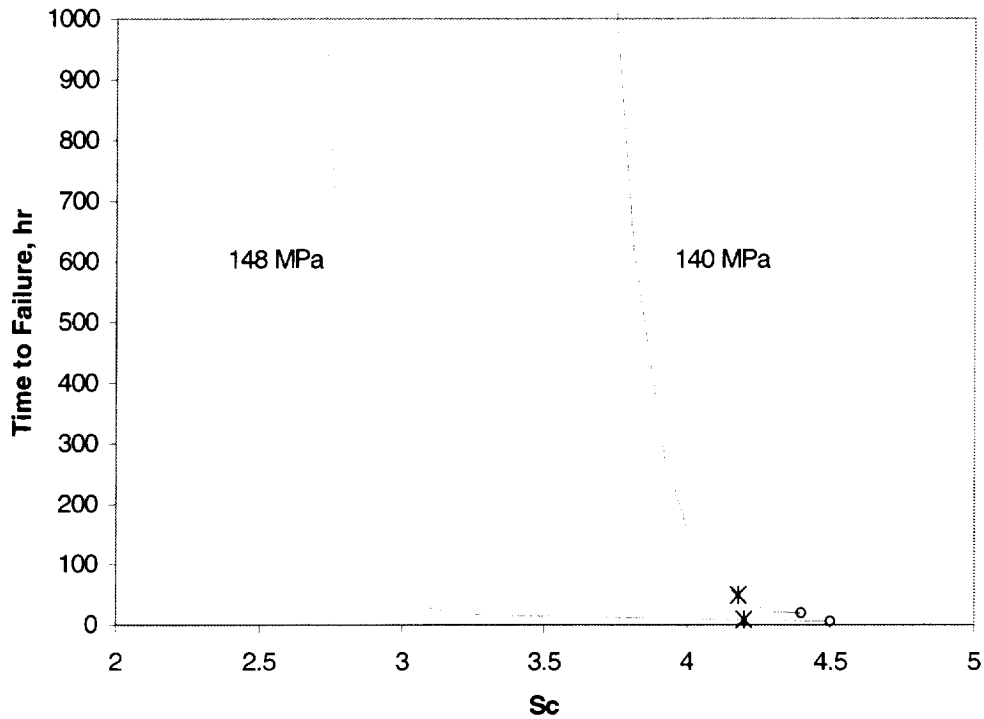
Figure 4.12: The effect of the stress concentration factor on the time to fail the second embrittled bundle in a matrix crack for MI composite rupture. The star data points indicate the measured rupture times for the composites. The circle data points indicate the time when the first fiber break was estimated.

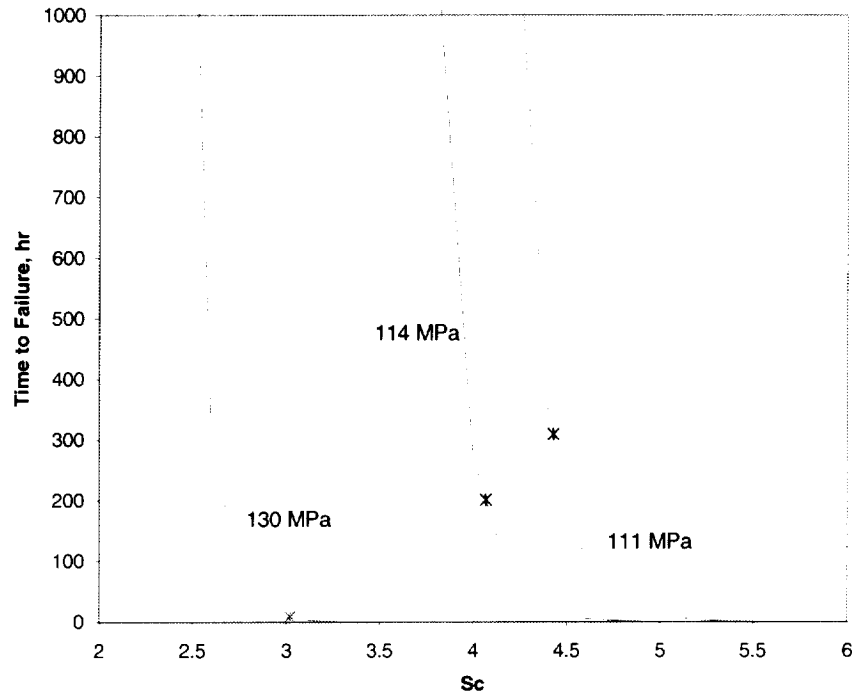
Figure 4.13: The effect of the stress concentration factor on the time to fail the second embrittled bundle in a matrix crack for CVI composite rupture. The star data points indicate the measured rupture times for the composites. All the curves were estimated to a minimum time to failure of 2 hours (the time to fully embrittle the cross-section of the composite). At least one fiber failure was estimated to occur prior to this time for each stress-condition.

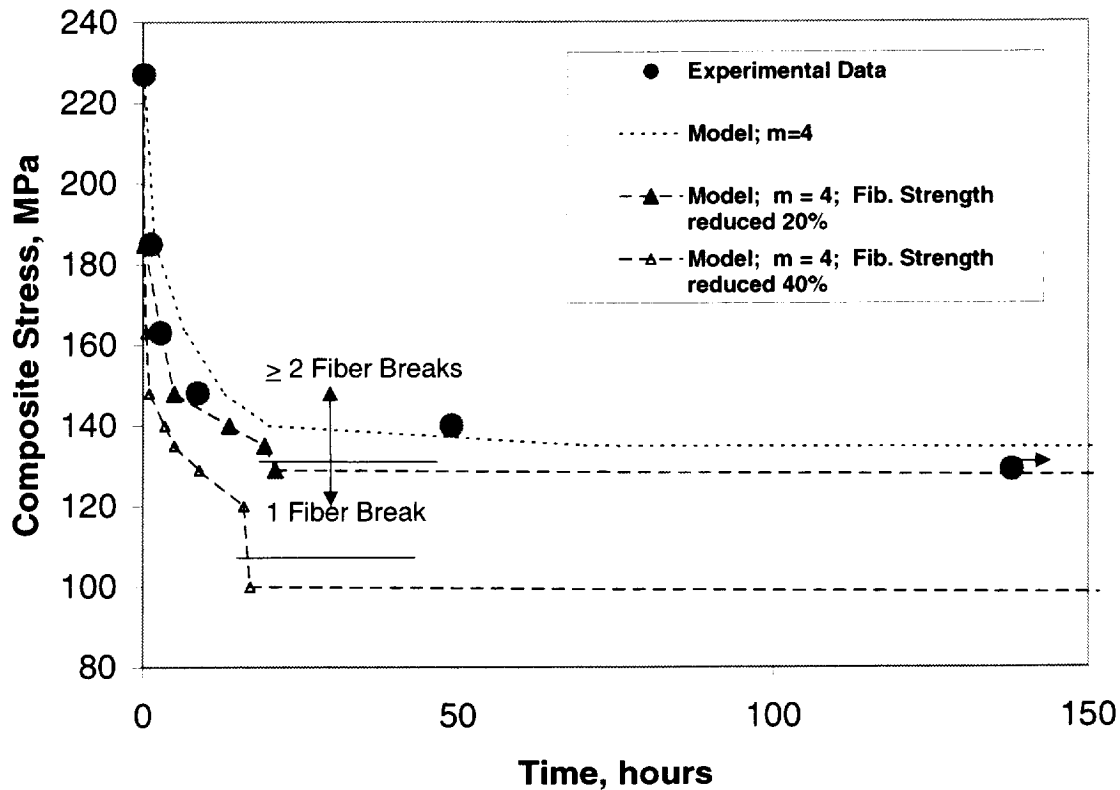
Figure 4.14: Rupture model with varying as-composited fiber strength.

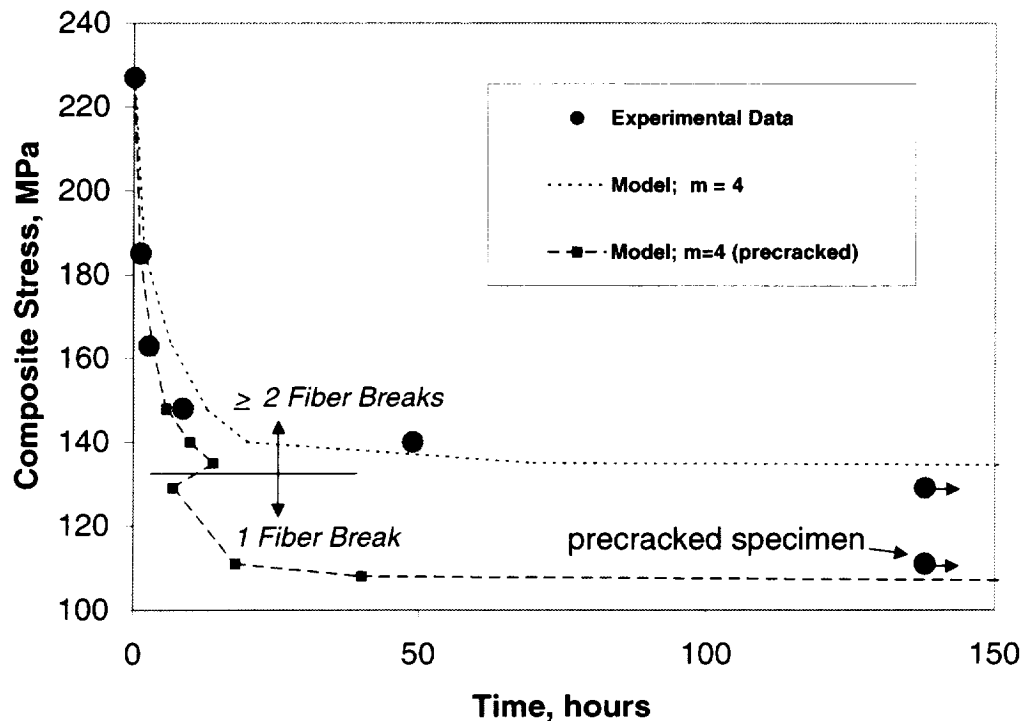
Figure 4.15: Rupture model with different crack densities.

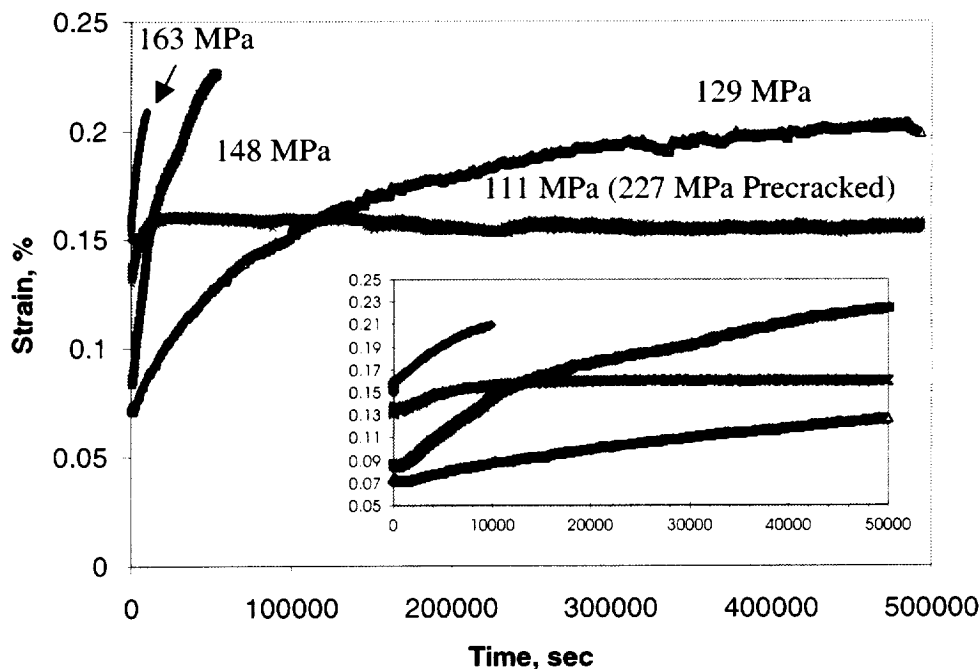
Figure 5.1: Strain versus time for the constant applied stress portion of the stress-rupture tests on some MI matrix composites.

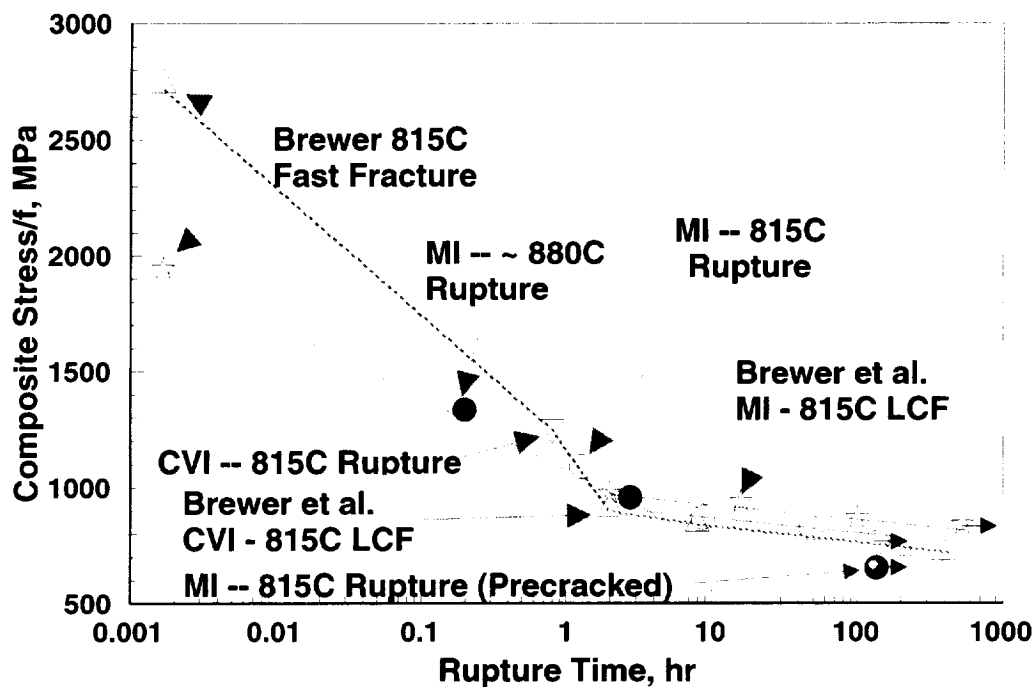
Figure 5.2: Composite stress normalized by volume fraction of fibers in the loading direction for the HN macrocomposite rupture and LCF data.

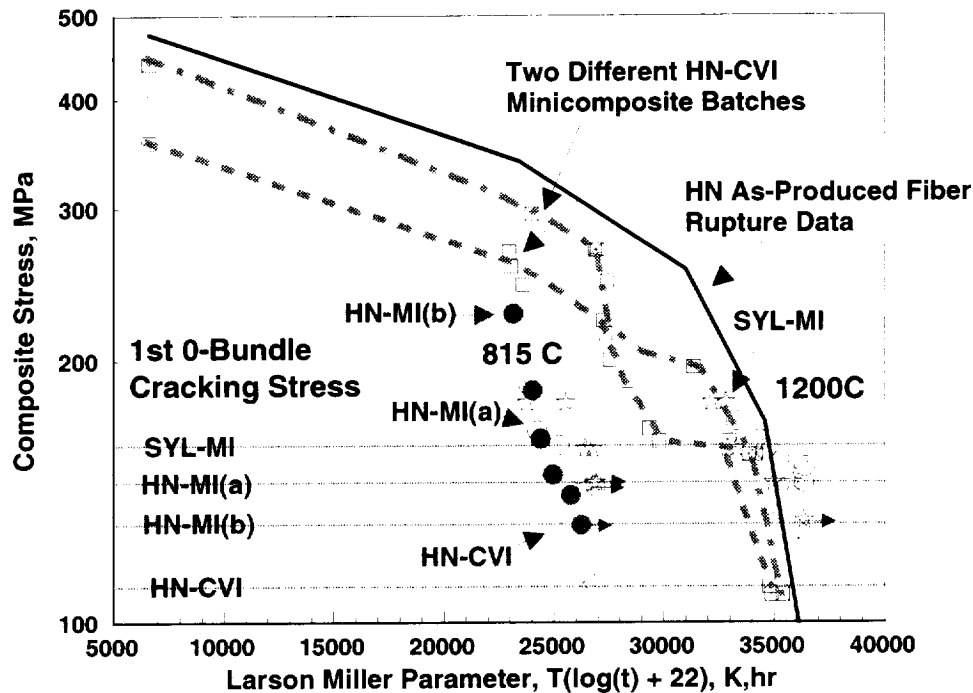
Figure 5.3: Larson-Miller plot from Figure 1.14 with data from this study (HN-MI(b)).

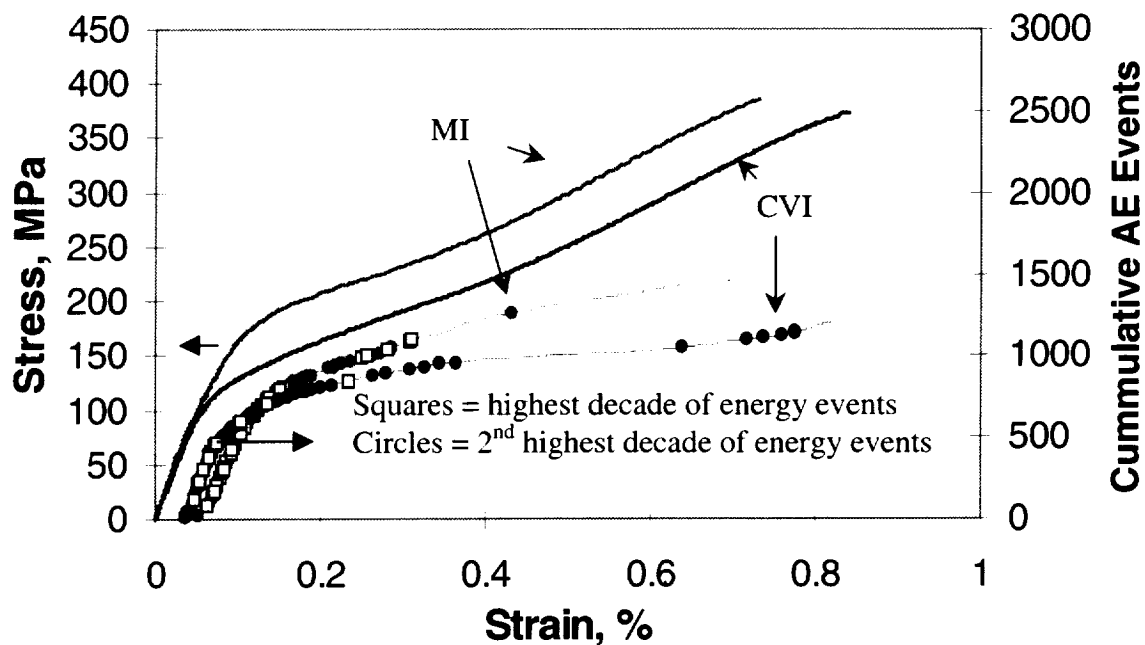
Figure A1: Tensile stress-strain and AE activity for Hi-Nicalon, MI and CVI matrix composites from references 1 and 7.

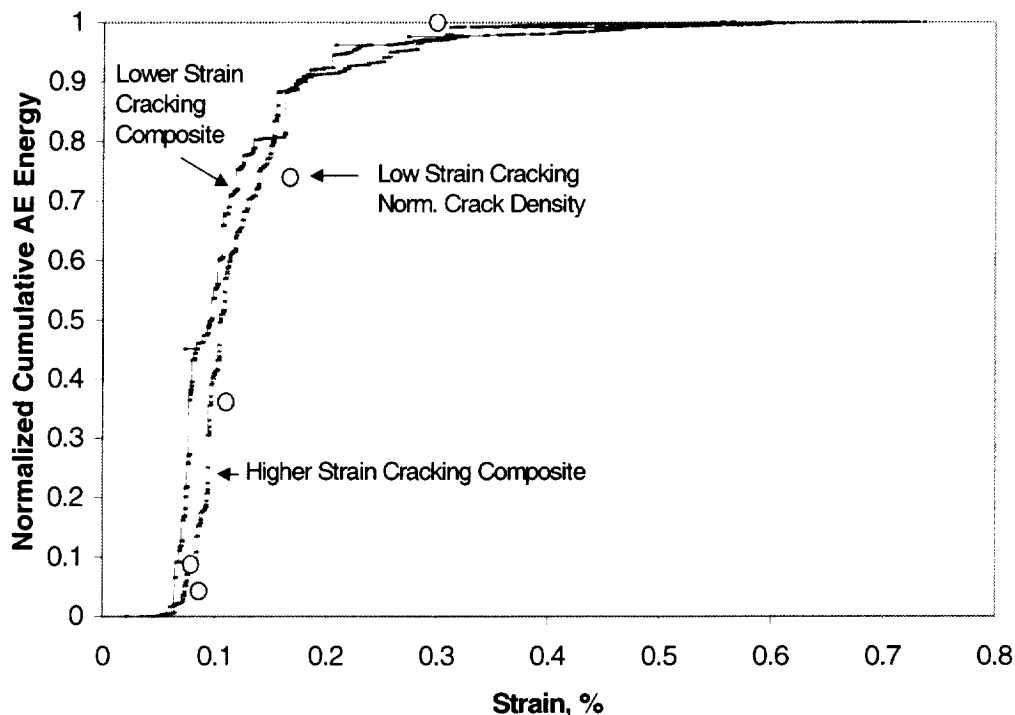
Figure A2: Comparison of cumulative AE energy from room temperature experiments and the linear crack density versus strain from crack-spacings measured in the cold section of ruptured samples.

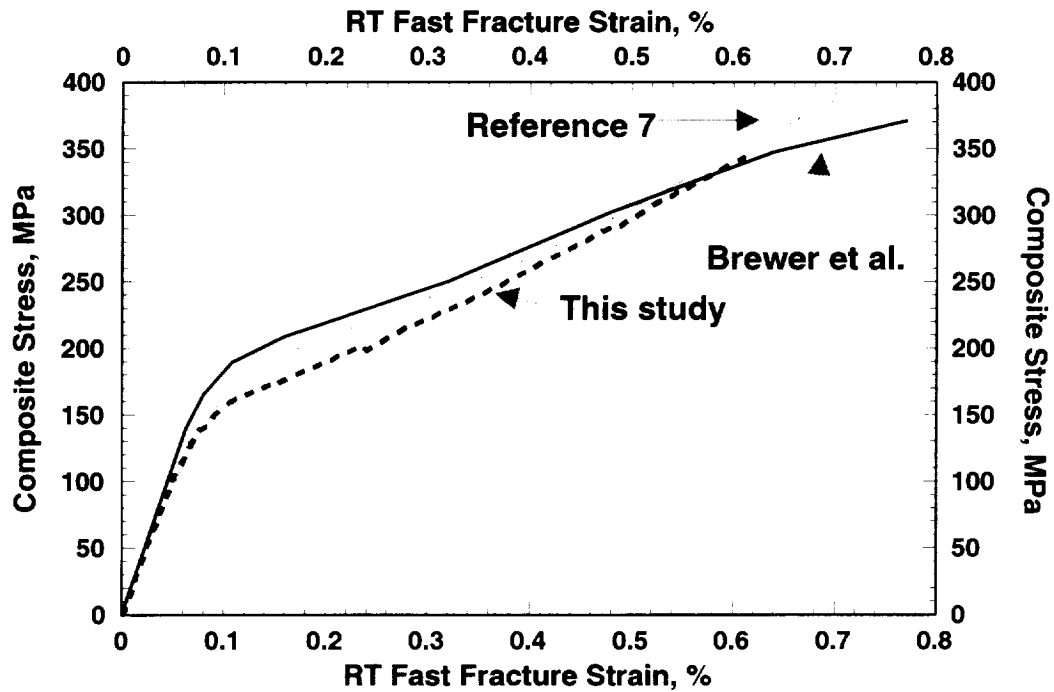
Figure A3: Stress-strain curves of different HN-BN-MI SiC composites.

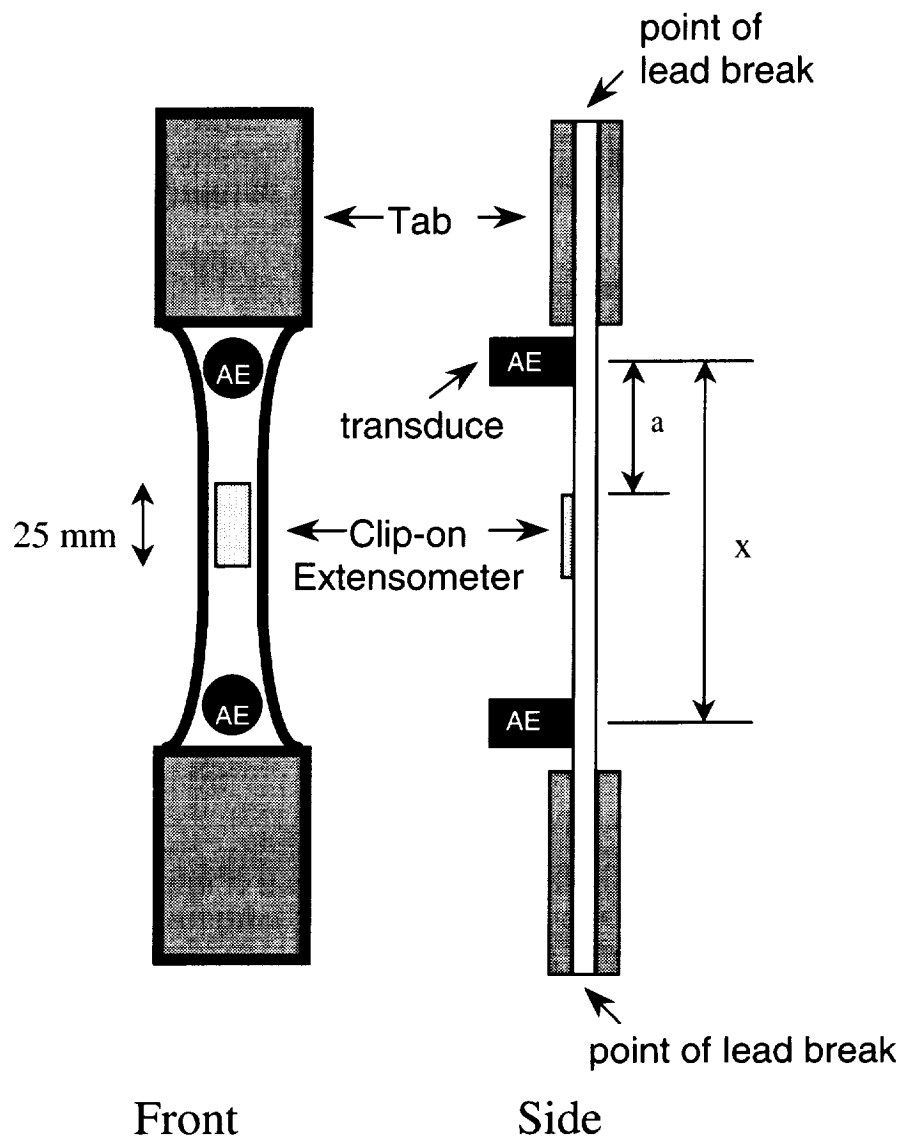
Figure A4: Typical AE sensor placement for room temperature tensile specimen. The specimen tested at room temperature from the same panel as the stress-rupture specimens was not a dogbone.

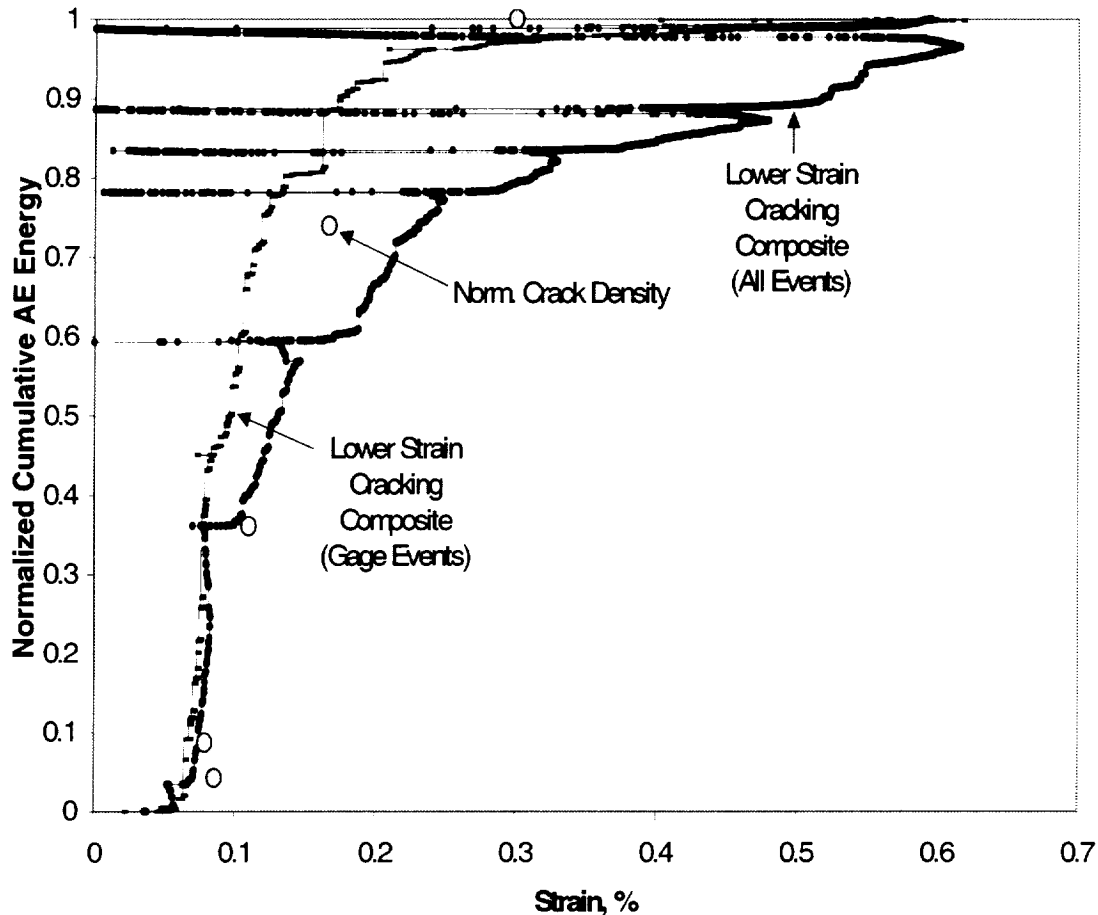
Figure A5: Comparison between the gage-separated and total number of AE events recorded during the unload-reload hysteresis tensile test for the “low strain cracking” composite. The normalized crack density is also plotted from the measured crack densities of the cold sections of rupture specimens.

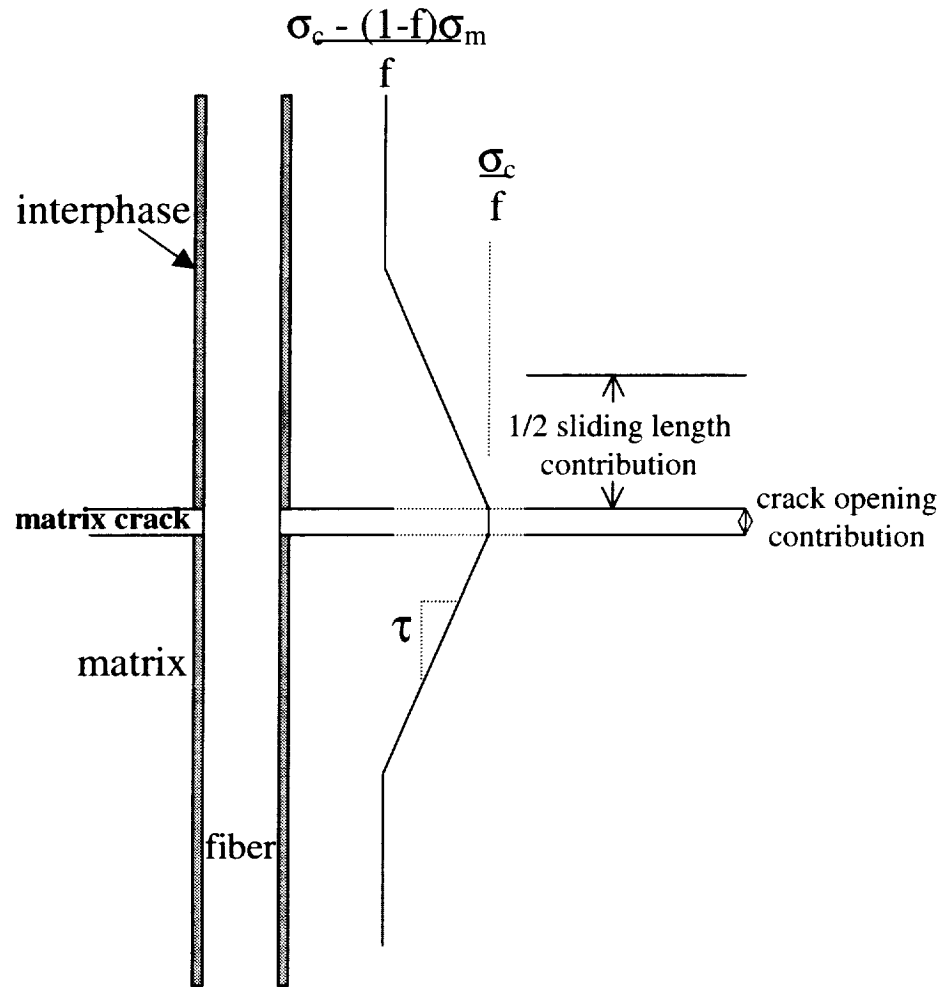
Figure B1: Schematic representation of stress-profile along the length of a fiber near and at a matrix crack (assuming the debond energy is zero).
